# Manhole Inspection Summary

Manhole # S21G1\_013MH

Insp Date: **4/29/08 10:58 AM**

**Location** Address: **2503 puget st**

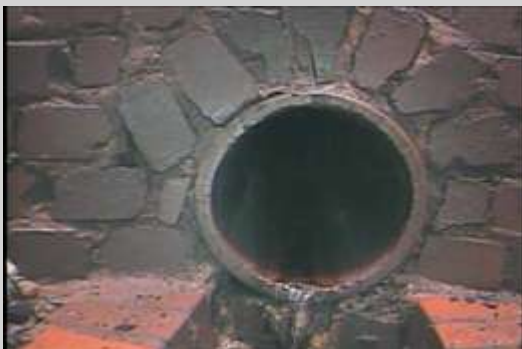
3 O'Clock Inflow

8 in. Circular Gravity Sewer  
Pipe In @ 3 O'Clock

Pipe Height: **8.4** (in.) Rod and Bar (Angled)  
Pipe Material: **Clay** ☐ Pipe Lined  
Invert Depth: **9.98** (ft.) Flow Characteristics: **Slow**  
Deposits: ☒ None ☐ Mud ☐ Sludge ☐ Debris ☐ Grease  
Silt Depth: **0** (in.) Deposits Extent:  
Infiltration: **None** Pipe Seal Cond: **Sound**

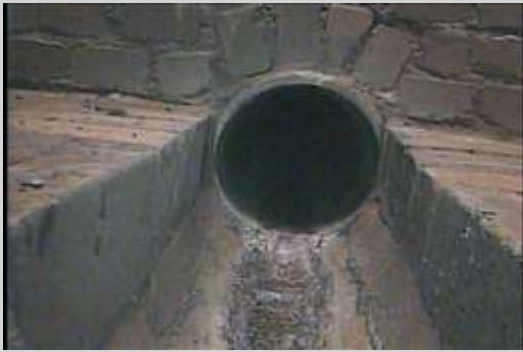
6 O'Clock Inflow

8 in. Circular Gravity Sewer

Pipe In @ 6 O'Clock

Pipe Height: **8.4** (in.) Rod and Bar (Angled)

Pipe Material: **Clay** ☐ Pipe Lined

Invert Depth: **10.40** (ft.) Flow Characteristics: **Slow**

Deposits: ☒ None ☐ Mud ☐ Sludge ☐ Debris ☐ Grease

Silt Depth: **0** (in.) Deposits Extent:

Infiltration: **None** Pipe Seal Cond: **Sound**

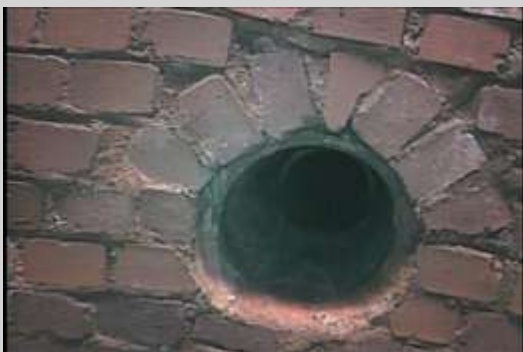
9 O'Clock Inflow

8 in. Circular Gravity Sewer

Pipe In @ 9 O'Clock

Pipe Height: **8.4** (in.) Rod and Bar (Angled)

Pipe Material: **Clay** ☐ Pipe Lined

Infiltration: **None** Pipe Seal Cond: **Sound**
